SAMPLE REPORT • OHIO

# See what a WALKED report looks like.

Inspection day • 10:00 AM • Clear  
Single-family brick ranch • attached one-car garage • Vacant • not occupied

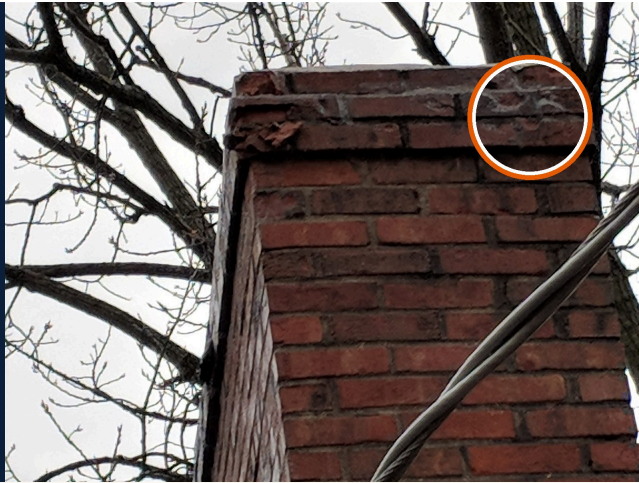
CHIMNEY, TOP COURSES

### Chimney top: cracked brick and broken mortar

At the top of the chimney, the mortar has broken out of the top rows of brick and some bricks are cracked.

*Water that gets in here works down into the chimney.*

Hire a mason or chimney contractor to rebuild the top courses and the crown.

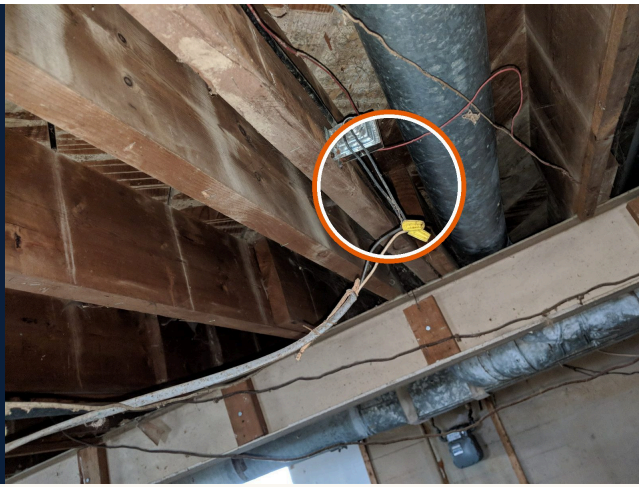
BASEMENT CEILING, BESIDE THE MAIN DUCT

## Wire connections hanging outside an open electrical box

A metal junction box in the basement ceiling has no cover. The splices sit outside the box, with the wire nuts hanging in the open below the joists.

*Splices belong inside a covered box so a loose connection can't touch wood or a hand.*

Hire a licensed electrician to move the connections into a covered box and fasten the cable.

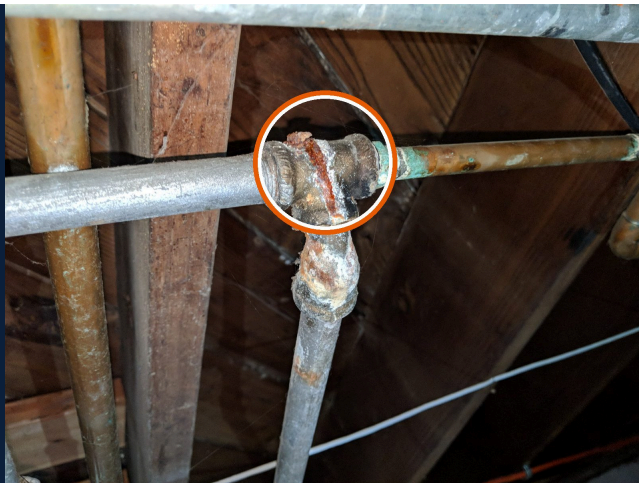
BASEMENT CEILING, SUPPLY LINES

## Galvanized steel water pipe, rusted at the fittings

Part of the water supply is galvanized steel. The fittings are rusted and swollen, with copper spliced in at some joints.

*Galvanized pipe rusts from the inside, which cuts water flow. The rusted fittings are where leaks start.*

Hire a licensed plumber to replace the galvanized supply piping.

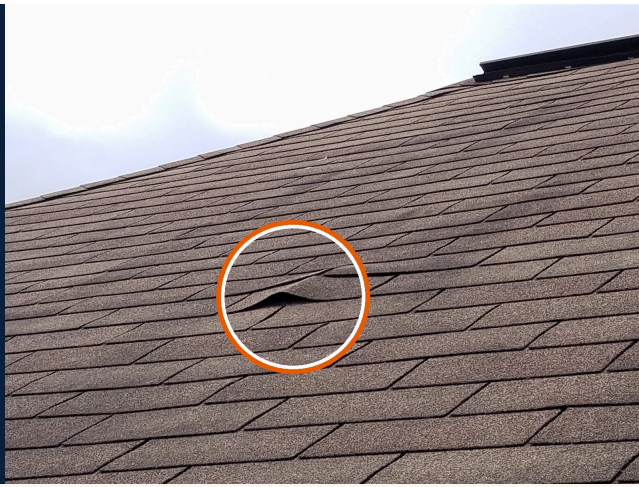
ROOF, MAIN SLOPE

## Damaged shingle: lifted and creased

One shingle is lifted and creased across the tab, so it no longer lies flat.

*A creased tab lets wind and water get under it, and the next storm can tear it off.*

Hire a licensed roofer to replace the damaged shingle and check the rest of the slope.

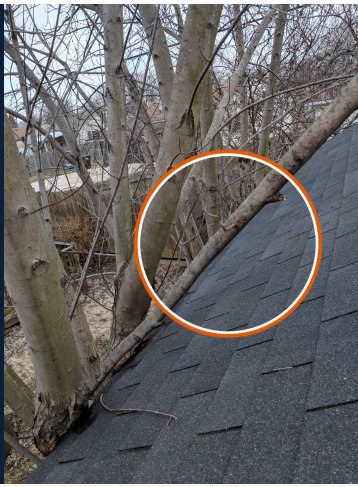
REAR ROOF EDGE

## Trees growing against the roof edge

Tree trunks and limbs rest on the roof edge and lie across the shingles.

*Limbs scrape off granules, hold debris and moisture on the roof, and give animals a path in.*

Hire a tree service to cut the limbs well back from the roof, then have a roofer check the shingles underneath.

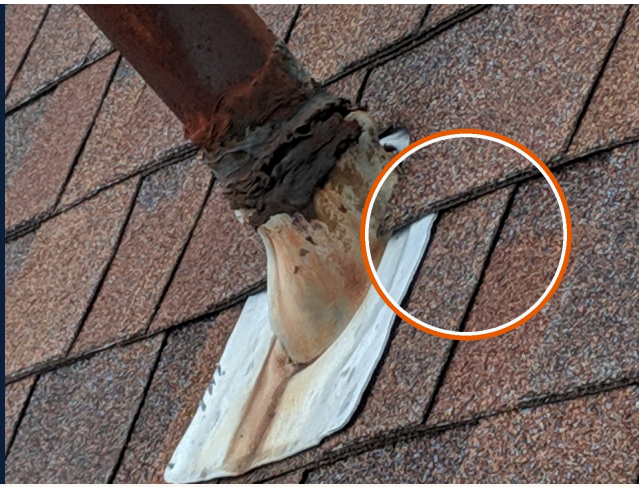
ROOF, PLUMBING VENT

## Rusted plumbing vent pipe, tar patch at the roof

The metal plumbing vent pipe is rusted through its surface, and the flashing boot around it is smeared with tar that has cracked.

*Rust and cracked tar where the pipe goes through the roof can let water into the attic.*

Hire a roofer, with a plumber if the pipe needs a new section, to replace the vent pipe stub and install a new boot.

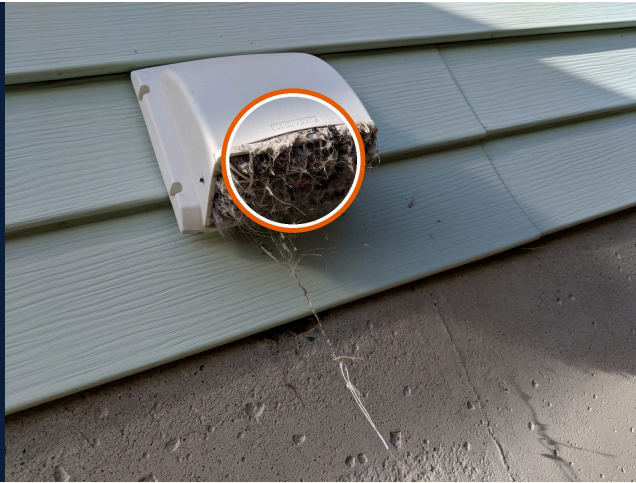
EXTERIOR, LAUNDRY WALL

### Dryer vent hood packed with lint

The outside dryer vent hood is stuffed with lint, and the flap can't open.

*A blocked dryer vent is a fire risk and makes the dryer run longer.*

DIY: pull the lint out of the hood by hand, then run a dryer-vent brush kit (hardware store) through the duct. Clean the lint screen every load.

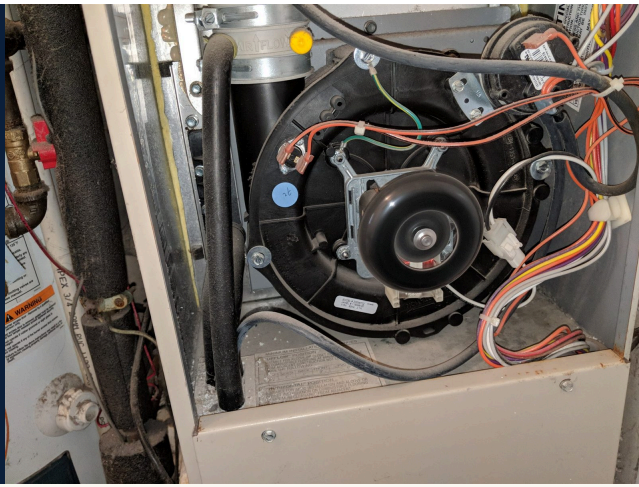
## Furnace • Gas furnace

Gas furnace, direct vent, forced air. Make: Ducane (Allied Air Enterprises). Model: CMPE050U3B. Serial: 4045430... Size: 50,000 BTU per hour input (plate).

*About 0 to 7 years left on a typical 15 to 25 year range (age from an unverified serial decode).*

Noted. Serial number dates it to 2008 (unverified decode). About 18 years old.

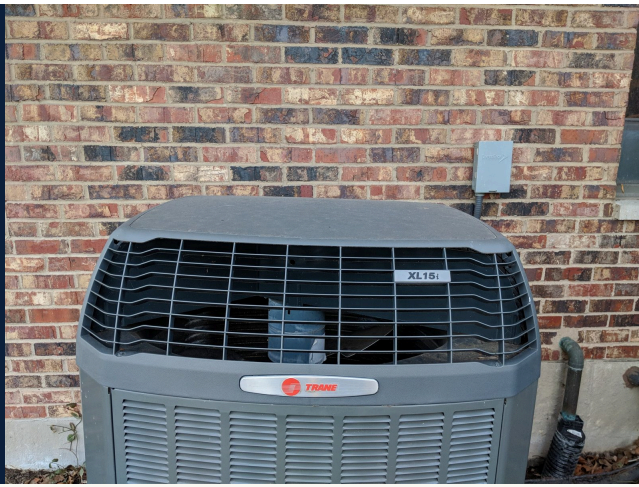
## Air conditioner • Outdoor AC

Central air conditioner, outdoor condensing unit. Make: Trane. Model: 4TTX5036A1000AA (XL15i). Serial: 8294WP... Size: model code suggests 3 tons (unverified); plate: MCA 22.0 A (minimum circuit amps: the smallest circuit the label calls for), max breaker 35 A.

*Past the typical 7 to 15 year range.*

Noted. Data plate dates it to 2008. About 18 years old.

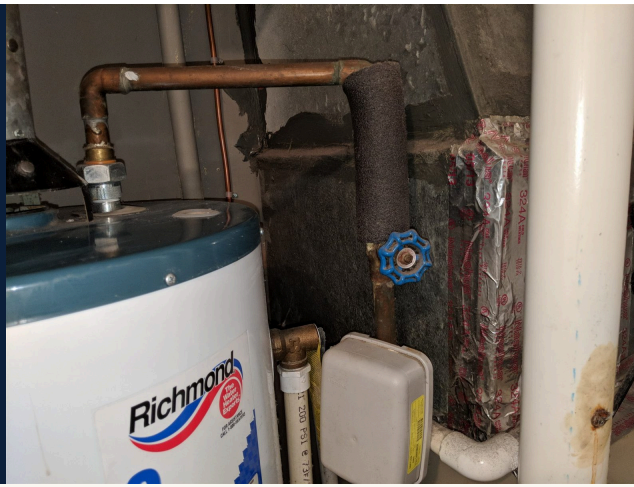
## Water heater • Gas tank

Tank water heater, atmospheric vent. Make: Richmond (Rheem Manufacturing Co.). Model: 6G40-36F1. Serial: RMLN0310412... Size: 40 gallons; 36,000 BTU per hour input (plate).

*Past the typical 6 to 12 year range.*

Noted. Data plate dates it to 2010. About 16 years old. The rusted galvanized pipe is a separate Hire a Pro item.

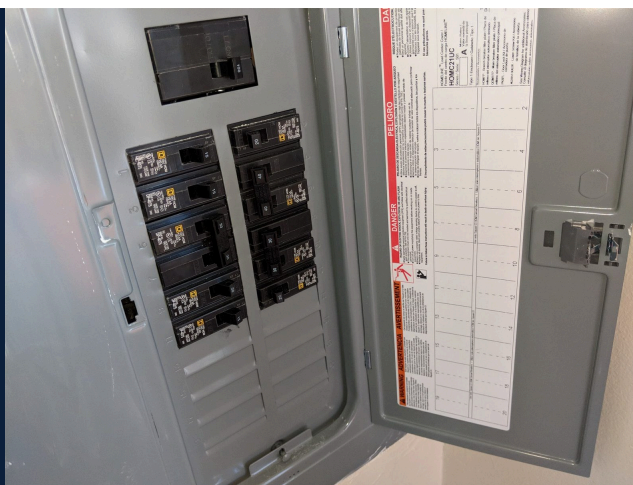
## Main electric panel • 100-amp main breaker

Main breaker panel, circuit breakers. Make: Square D Homeline. Model: HOMC21UC (door label). Serial: none on the label. Main breaker handle reads 100 amps.

Noted. No manufacture date on the label in these photos, so age is not determined. The open wire splices are a separate Hire a Pro item.

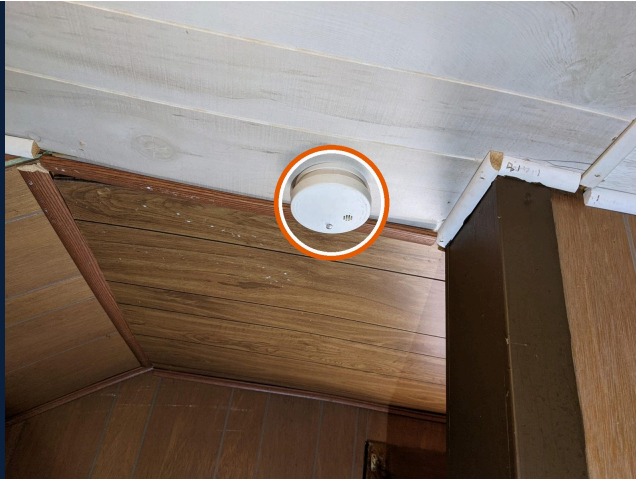
HALL CEILING

## Smoke alarm present in the hall

A smoke alarm is mounted on the hall ceiling. It wasn't tested.

Noted. Test it the day you move in.
