SAMPLE REPORT • OHIO

# See what a WALKED report looks like.

Inspection day • 10:00 AM • Clear  
Single-family brick ranch • attached garage (side entry) • Vacant • not occupied

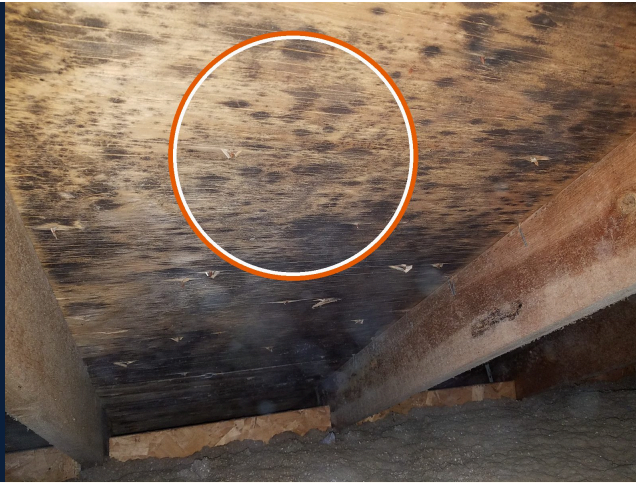
ATTIC, ROOF BOARDS (SHEATHING)

### Mold-like growth on attic roof sheathing

Dark, spotty mold-like growth covers the underside of the roof sheathing between the rafters.

*Growth like this points to moisture in the attic. It comes back until the cause is fixed.*

Mold-like growth was seen on the attic roof boards. Only a lab test can say what it is.

Hire a mold pro to evaluate the mold-like growth, and a roofer or ventilation contractor to check the attic vents and roof boards.

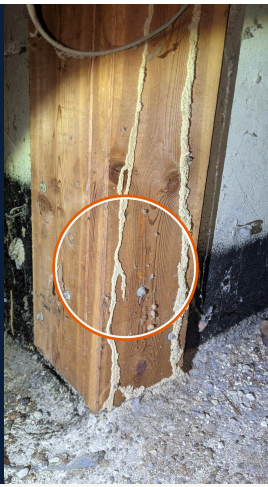
BASEMENT, POST AND PIER

## Mud tubes on wood and block

Mud tubes run across the wood and block.

*Wood-eating insects such as termites build tubes like these. Damage inside the wood may not show.*

Mud tubes were seen. A pest pro can tell you if insects are active and how much wood is damaged.

Hire a licensed pest control company to inspect for termites and other wood-eating insects, and have a carpenter check the wood.

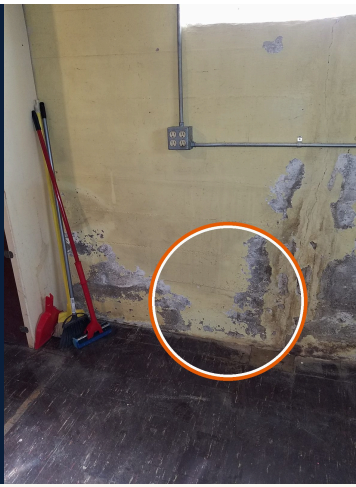
BASEMENT, REAR WALL

## Water staining and white mineral deposits on the basement wall

The lower basement wall has white crusty deposits (efflorescence) and tan water staining running down from above, with the paint flaking off.

*Water is moving through this wall. The deposits are the minerals it leaves behind.*

Hire a basement waterproofing contractor to find where the water comes in. Start with the gutters, downspouts and grading on that side.

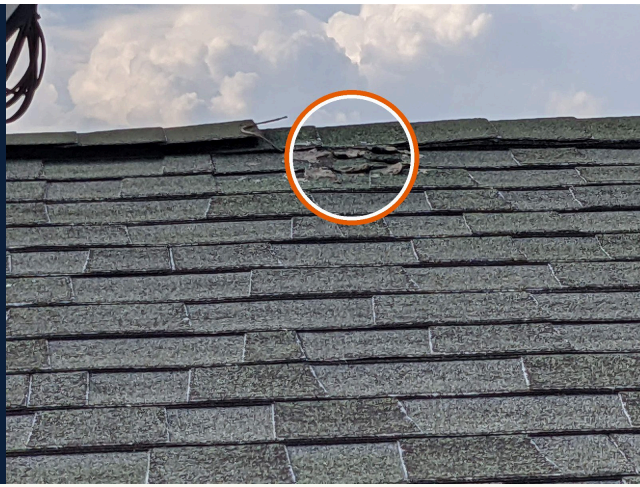
ROOF, NEAR THE RIDGE

## Damaged shingles: torn at the ridge

Shingles near the ridge are torn, with pieces missing.

*Open spots let water reach the roof deck.*

Hire a licensed roofer to replace the torn shingles and check the ridge.

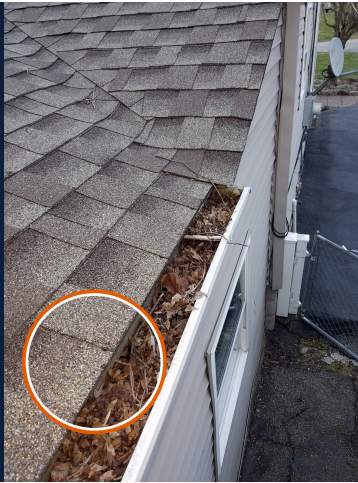
GUTTERS, SIDE OF THE HOUSE

## Gutters packed with leaves

The gutter is packed with dry leaves along this run.

*Clogged gutters overflow, and the water lands at the foundation.*

DIY: from a sturdy ladder on level ground, scoop out the leaves by hand and flush the gutter with a hose until the downspout runs clear. Repeat each fall after the leaves drop.

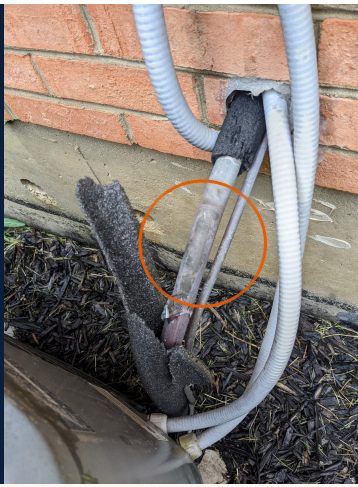
EXTERIOR, AC PIPES AT THE WALL

## Refrigerant line insulation torn off at the wall

The foam insulation on the large AC refrigerant line is torn and hanging off, leaving bare copper.

*Bare pipe loses cooling and drips.*

DIY: slide on new foam pipe insulation sized for the line and wrap the seams with UV-resistant tape.

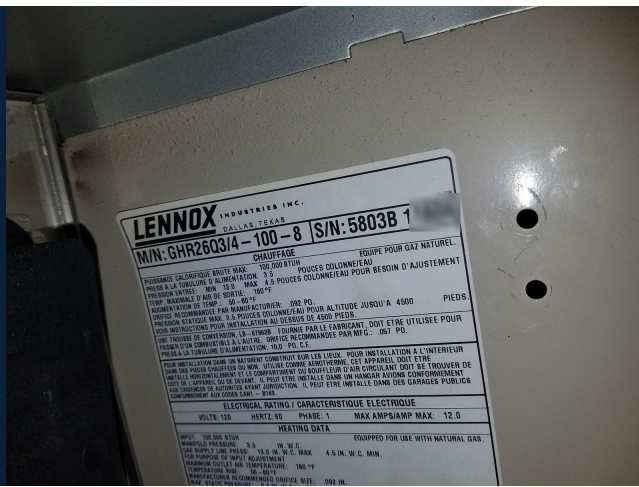
HEAT  
2003 (unverified)

# Furnace • Gas furnace

Gas furnace, forced air. Make: Lennox. Model: GHR26Q3/4-100-8. Serial: 5803B11... Size: 100,000 BTU per hour input (plate); 120 V, max 12.0 A (plate).

*About 0 to 2 years left on a typical 15 to 25 year range (age from an unverified serial decode).*

Noted. Serial number dates it to 2003 (unverified decode). About 23 years old.

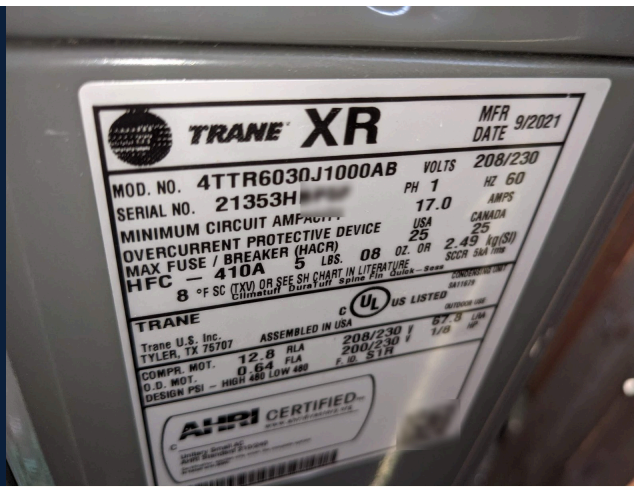
COOLING  
2021

## Air conditioner • Outdoor AC

Central air conditioner, outdoor condensing unit. Make: Trane (XR). Model: 4TTR6030J1000AB. Serial: 21353HB... Size: model code suggests 2.5 tons (unverified); plate: MCA 17.0 A (minimum circuit amps: the smallest circuit the label calls for), max breaker 25 A.

*About 2 to 10 years left on a typical 7 to 15 year range.*

Noted. Data plate dates it to 2021. About 5 years old. Torn line insulation is a separate DIY.

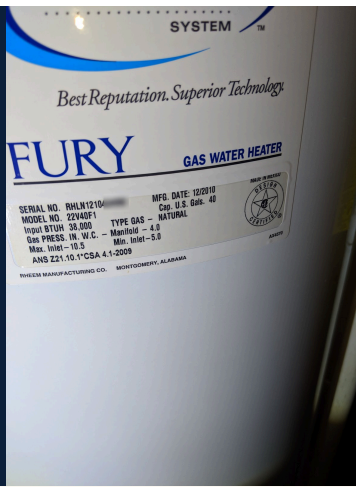
WATER  
2010

## Water heater • Gas tank

Tank water heater. Make: Rheem (Fury). Model: 22V40F1. Serial: RHLN1210424... . Size: 40 gallons; 38,000 BTU per hour input (plate).

*Past the typical 6 to 12 year range.*

Noted. Data plate dates it to 2010. About 15 years old.

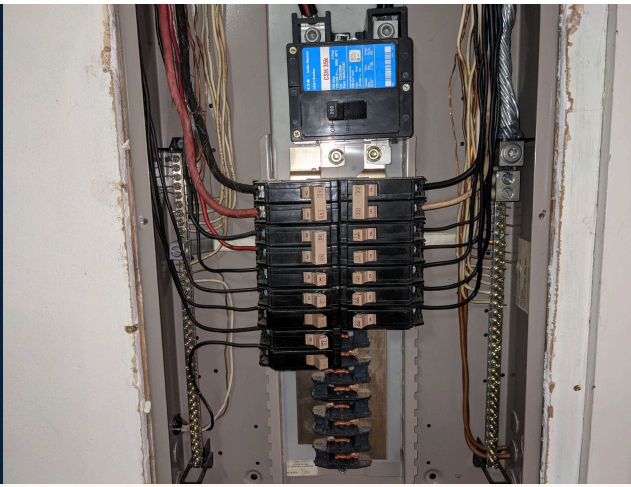
POWER

## Main electric panel • 200-amp main breaker

Main breaker panel, circuit breakers. Make: Eaton Cutler-Hammer (main breaker label). Model: CSH 35k main breaker, Cat. CSH2200N (breaker label); panel label not photographed. Serial: none on the label. Main breaker handle and label read 200 amps.

Age not determined

Noted. No manufacture date on the label in these photos, so age is not determined.

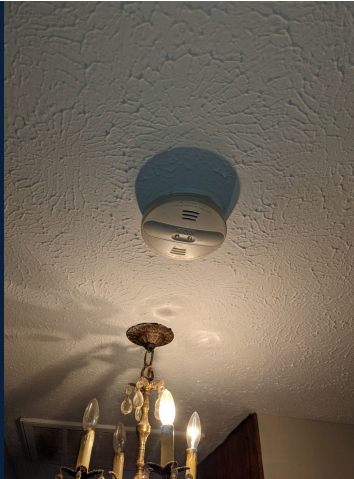
CEILING BY THE LIGHT FIXTURE

## Smoke alarm present in the hall

A smoke alarm is mounted on the ceiling next to a light fixture. It wasn't tested.

Noted. Test it the day you move in.
