## Sample report

# See what a WALKED report looks like.

Single-family two-story frame house • no garage • Vacant • not occupied

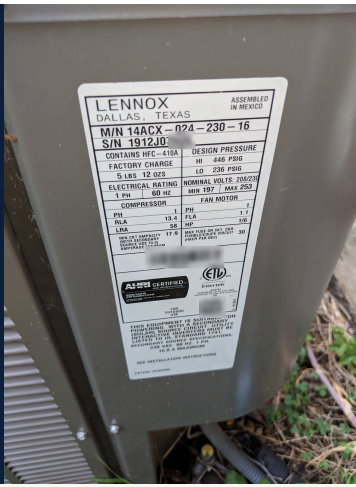
Central air conditioner, outdoor condensing unit. Make: Lennox. Model: 14ACX-024-230-16. Serial: 1912J07... Size: model code suggests 2 tons (unverified); plate: MCA 17.9 A (minimum circuit amps: the smallest circuit the label calls for), max breaker 30 A.

*About 0 to 1 year left on a typical 7 to 15 year range (age from an unverified serial decode).*

Noted. Serial number dates it to 2012 (unverified decode). About 14 years old.

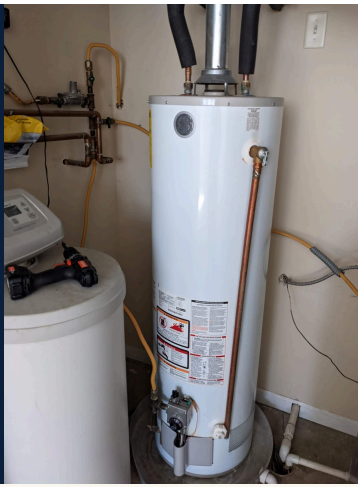
Tank water heater. Make: GE (built under license by Rheem Mfg. Co., per plate). Model: GG40T06AVG01. Serial: GELNQ011433... Size: 40 gallons; 36,000 BTU per hour input (plate).

*At the end of the typical 6 to 12 year range.*

Noted. Data plate dates it to 2014. About 12 years old.

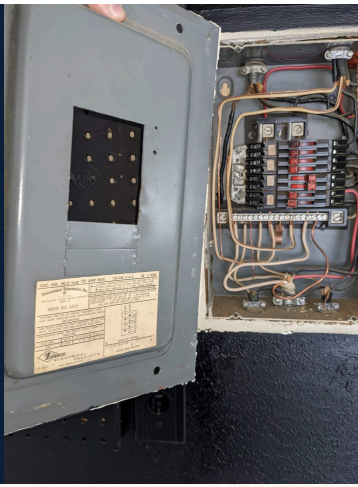
Breaker panel, circuit breakers (enclosed panel-base assembly, label). Make: Zinsco Electrical Products. Model: Cat. No. ML12. Serial: none on the label. Panel label says 125 amps max. With the cover open there is no main breaker in this panel: the service wires land on lugs at the top. Branch breakers read 20 amps.

Noted. Label read; it carries no manufacture date, so age is not determined. The knob-and-tube wiring is a separate Hire a Pro item.
