SAMPLE REPORT • OHIO

# See what a WALKED report looks like.

Inspection day • 10:00 AM • Clear  
Single-family brick ranch • attached one-car garage • Vacant • not occupied

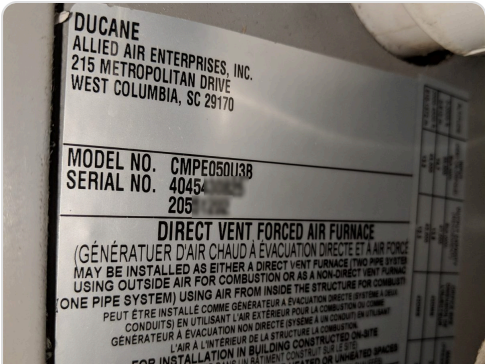
Equipment schedule · Furnace data plate

Noted. Serial number dates it to 2008 (unverified decode). About 18 years old.

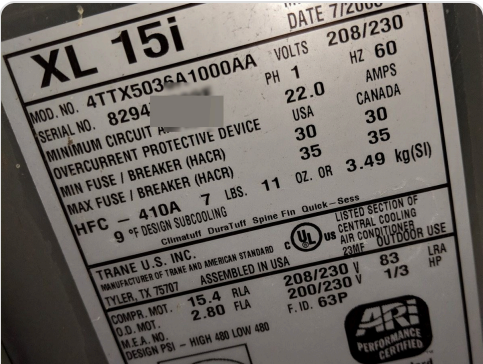
Equipment schedule · Air conditioner data plate

Central air conditioner, outdoor condensing unit. Make: Trane. Model: 4TTX5036A1000AA (XL15i). Serial: 8294WP... Size: model code suggests 3 tons (unverified); plate: MCA 22.0 A (minimum circuit amps: the smallest circuit the label calls for), max breaker 35 A.

Noted. Data plate dates it to 2008. About 18 years old.

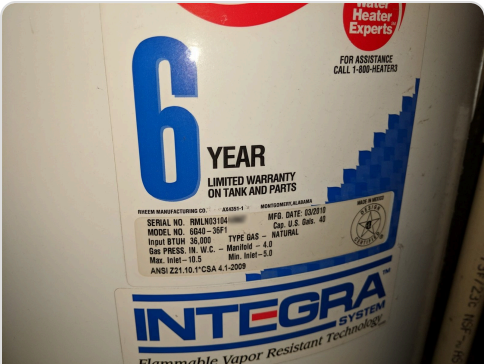
Equipment schedule · Water heater data plate

Noted. Data plate dates it to 2010. About 16 years old. The rusted galvanized pipe is a separate Hire a Pro item.

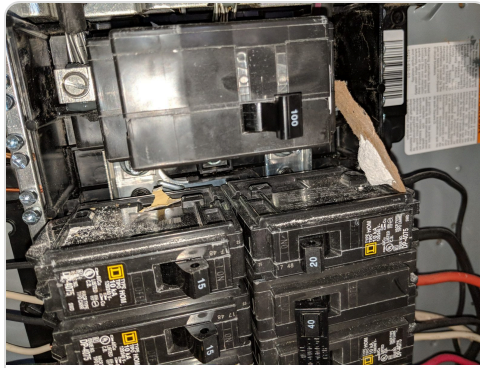
Equipment schedule · Main electric panel data plate

Noted. No manufacture date on the label in these photos, so age is not determined. The open wire splices are a separate Hire a Pro item.
